# GENERAC®

### ENTERTAINMENT COMPLEX

## CASE STUDY

Generac 5.5 MW MPS solution consisting of five, 1000 kW Gemini diesel generators and one MD500 kW diesel generator.

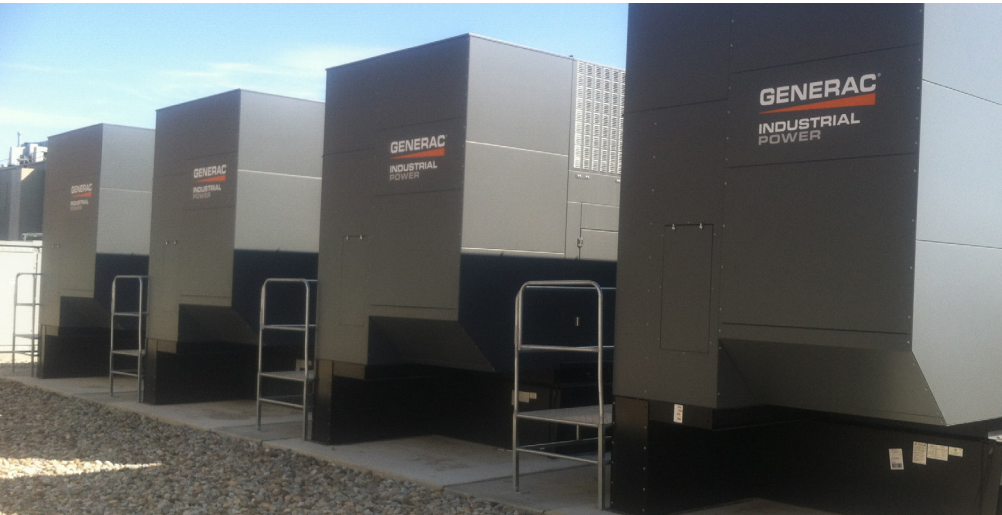
**APPLICATION:**

Entertainment

**SYSTEM CONFIGURATION:**

5.5 MW MPS

**MODELS:**

5x 1000 kW Gemini diesel generators,  
1x MD500 kW diesel generator
